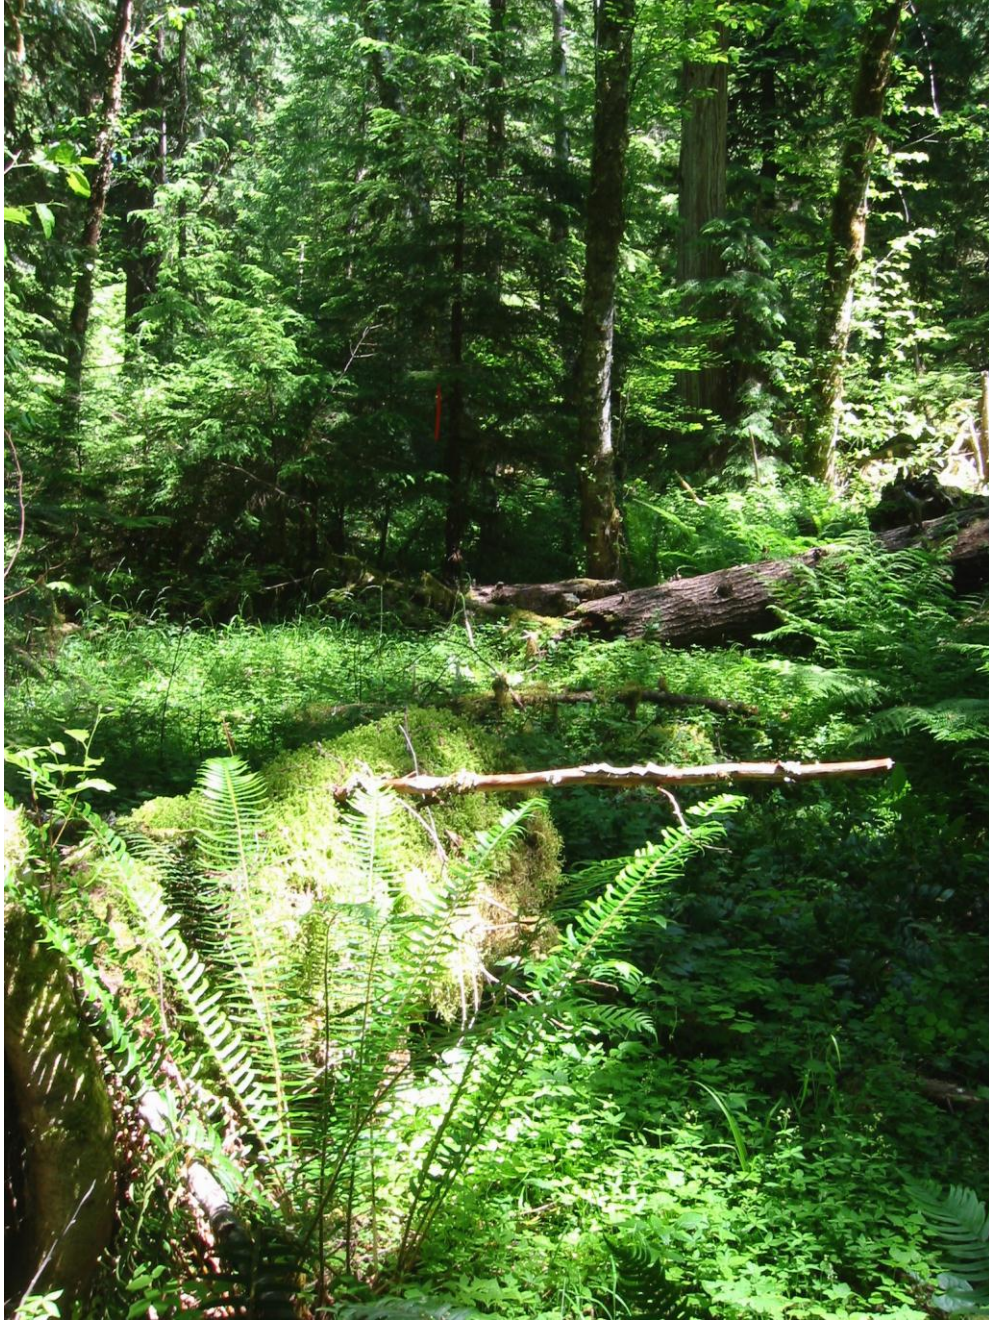
Photo 1. Red flag in shadow in upper center of photo demarcates alignment of the route identified as U18PR in my comments, which the Project proposes to reopen to access logging unit 18. The flagged alignment has significant stocking of trees >6 inches dbh, although this is not divulged in the EA. There is abundant downed wood and the soils along the alignment of the proposed road have fully recovered with respect to hydrology and erosion. The alignment is also covered with a variety of vegetation, downed wood, trees, and forest litter. Although it is not made known in the EA, due to the level of recovery on this road, re-opening will basically entail new construction in resulting in severe and persistent soil, riparian, and erosion impacts, contrary to the incorrect assessment in the EA. These impacts will also irretrievably reverse all recovery that has occurred on this alignment over several decades and permanently reduce soil productivity.

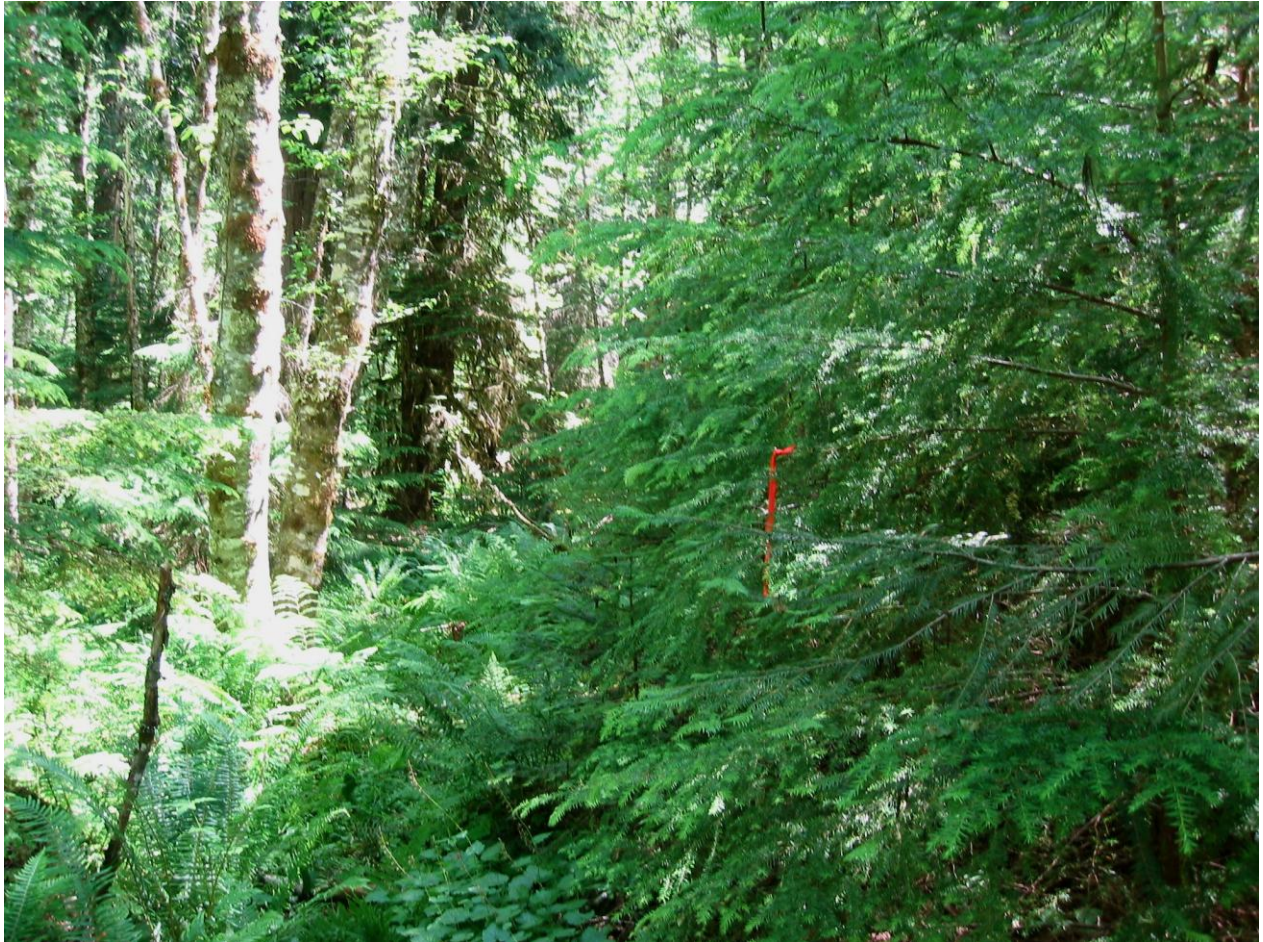
Photo 2. Another view of the alignment of the route identified as U18PR in my comments. The red flag in the photo demarcates the alignment that the Project proposes to reopen to access logging unit 18. The flagged alignment has significant stocking of trees >6 inches dbh, although this is not divulged in the EA. There is abundant downed wood and the soils along the alignment of the proposed road have fully recovered with respect to hydrology and erosion. The alignment is covered with a variety of vegetation, downed wood, trees, and forest litter. Although it is not made known in the EA, due to the level of recovery on this road, re-opening will cause impacts akin to new road construction in resulting in severe and persistent soil, riparian area, and erosion impacts, contrary to the incorrect assessment in the EA.

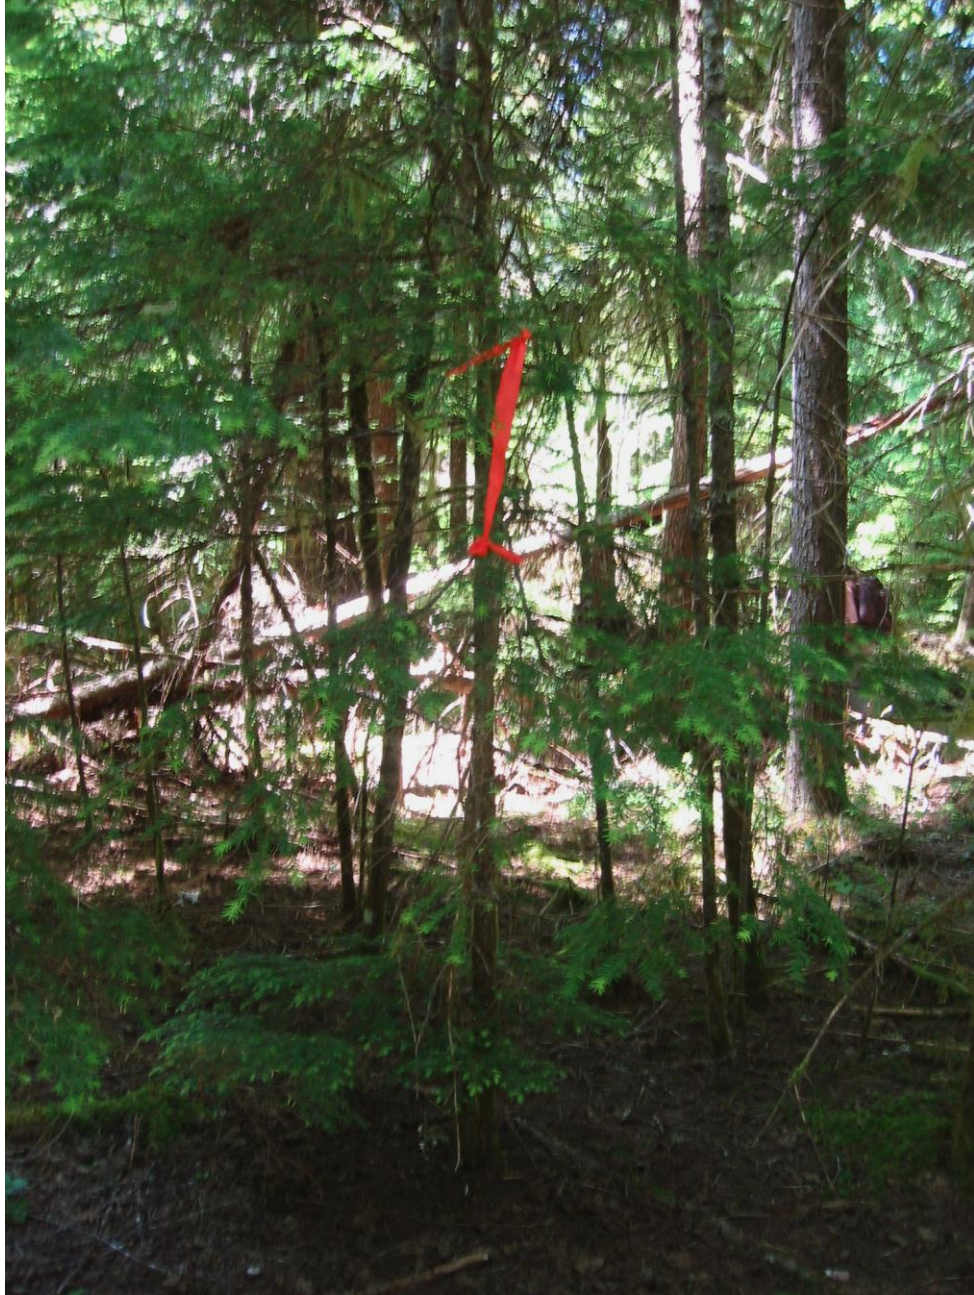
Photo 3. Another view of another part of the alignment of the route identified as U18PR in my comments. The red flag in the photo demarcates the alignment that the Project proposes to reopen to access logging unit 18. The flagged alignment has significant stocking of trees >6 inches dbh, although this is not divulged in the EA. There is abundant downed wood and the soils along the alignment of the proposed road are fully covered with a variety of vegetation, downed wood, trees, and forest litter. Although it is not made known in the EA, due to the level of recovery on this road, re-opening will have impacts akin to new road construction in resulting in severe and persistent soil, riparian area, and erosion impacts, contrary to the incorrect assessment in the EA.

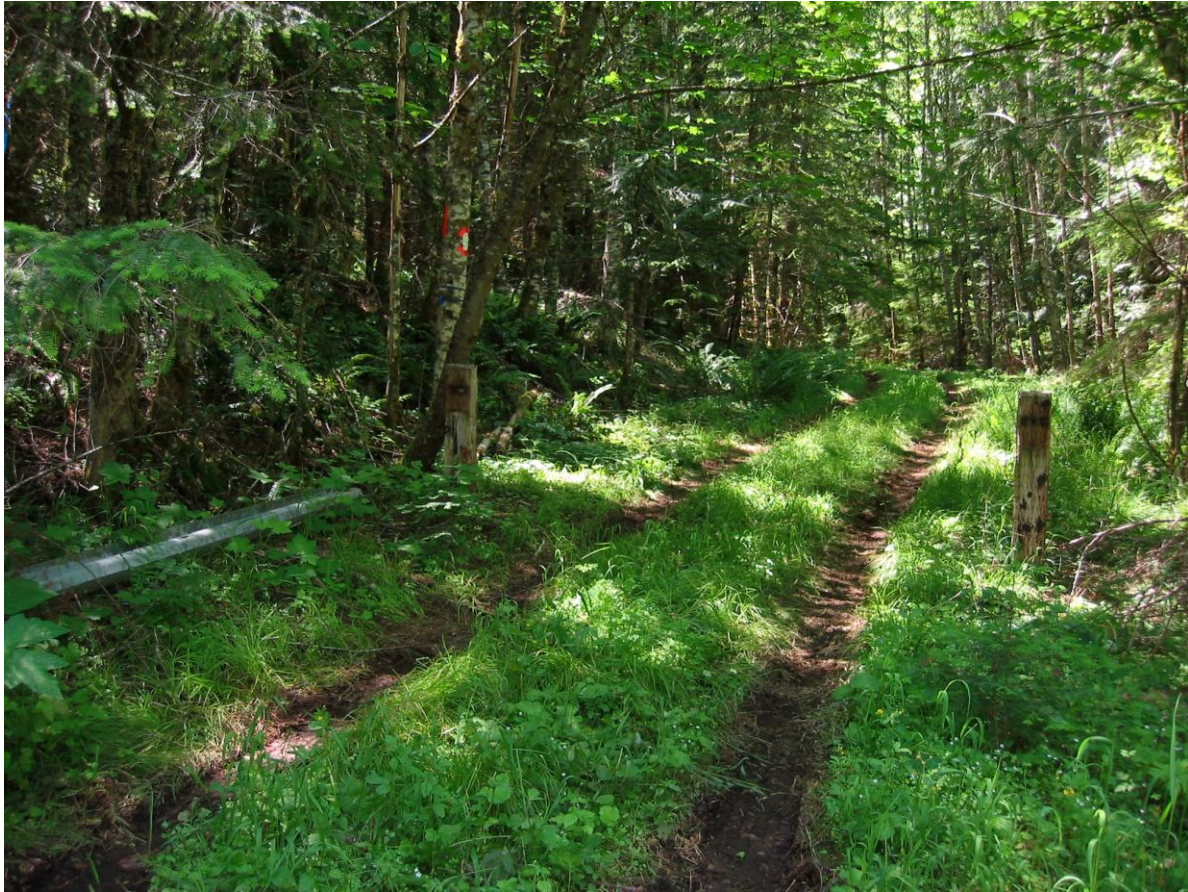
Photo 4. Supposedly closed road that would be reconstructed and opened under the Project. This closed road had revegetated through non-use, although some of the revegetation that occurred with non-use was reversed by vehicular use when the gate on the road was opened. Based on my July 5, 2012 observations, the opening of gate and road use appears to have been done to begin remove trees on the road in advance of the release of the final EA (see following photo). The reconstruction of this road needed to open it will have major adverse impacts on soils, erosion, sediment delivery, and runoff. It will also reverse years of vegetative, soil, and hydrologic recovery on this abandoned road, which will require several many years to attain after decommissioning.

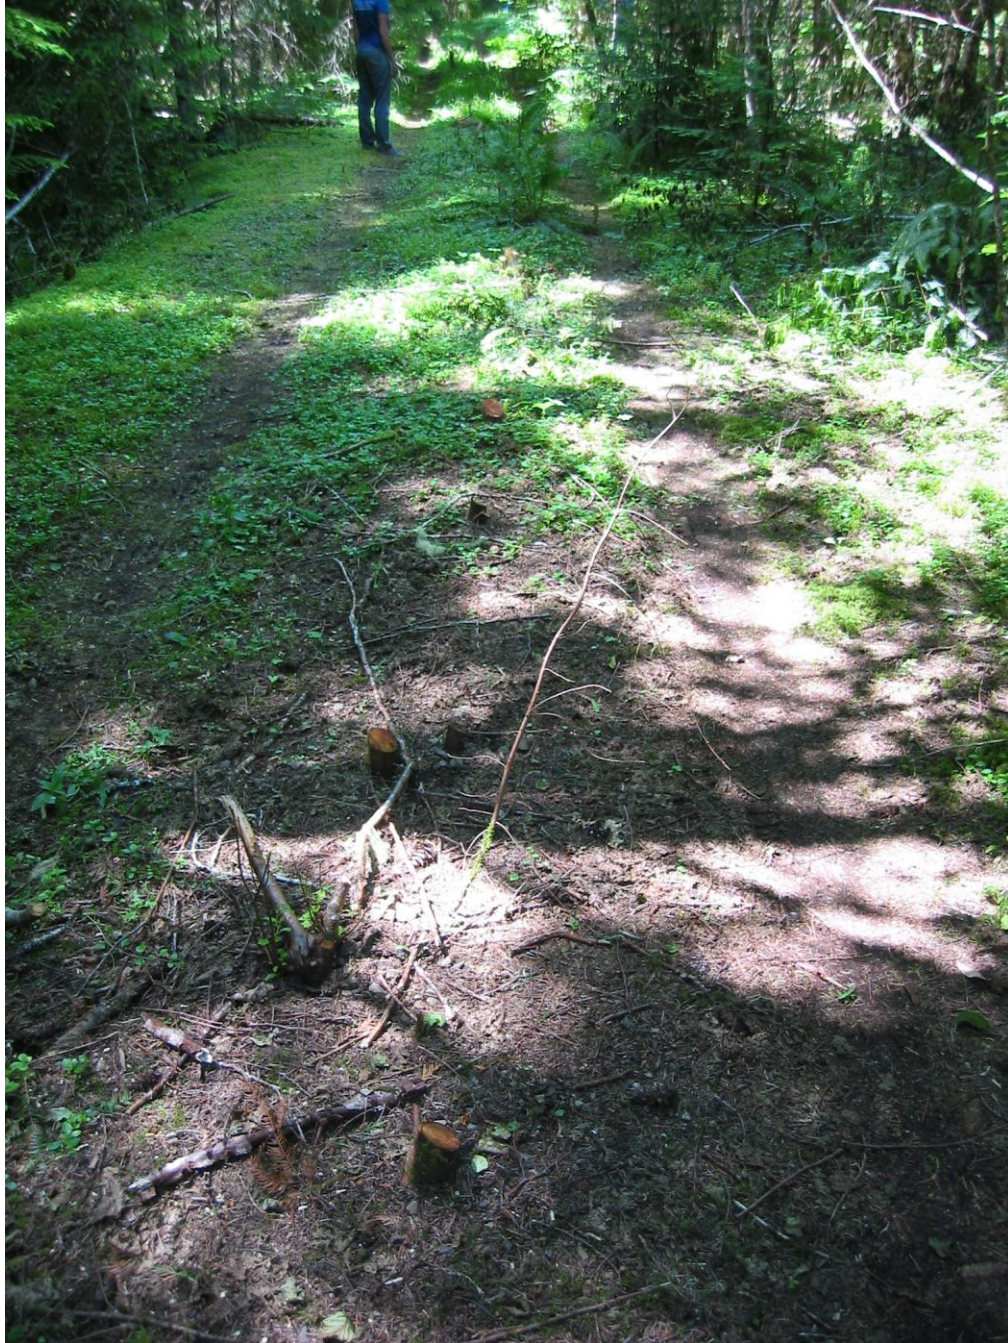
Photo 5. Supposedly closed road proposed to be reconstructed and opened under the Project. This closed road had revegetated through non-use, although some of the revegetation that occurred with non-use was reversed by vehicular use when the gate on the road was opened. Based on my July 5, 2012 observations, the opening of gate and road use appears to have been done to begin remove trees on the road in advance of the release of the final EA. The stumps in the center of the photo had plainly been recently cut prior to my July 5, 2012 field visit. The revegetation on the road that occurred with non-use as been reversed by use when the gate on the road was opened and vehicular use ensued. The reconstruction of this road needed to open it will have major adverse impacts on soils, erosion, sediment delivery, and runoff. It will also reverse years of vegetative, soil, and hydrologic recovery on this road.
