BARK

November 1, 2010

PHOTOS FROM THE JAZZ TIMBER SALE, Scoping 2010

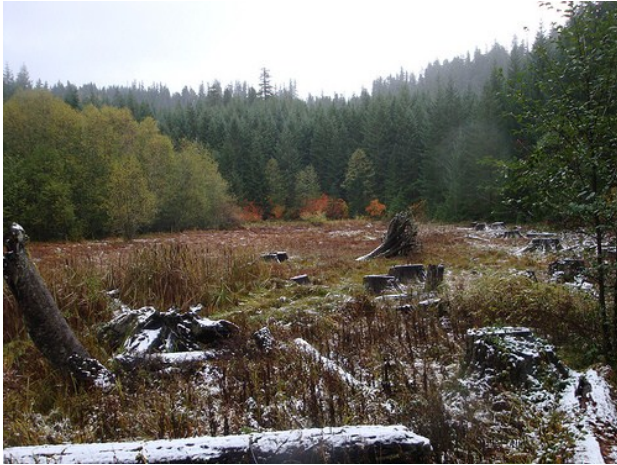
↙ This wetland is indicative of the impacts logging have had on this dynamic landscape. The logging from before allowed the drainage to spread out and has now created a diffused wetland area. Unit 4 is straight ahead in this photo and wraps around to the south (right). We expect there to be an analysis of the natural history of this area that factors the impacts of past logging.

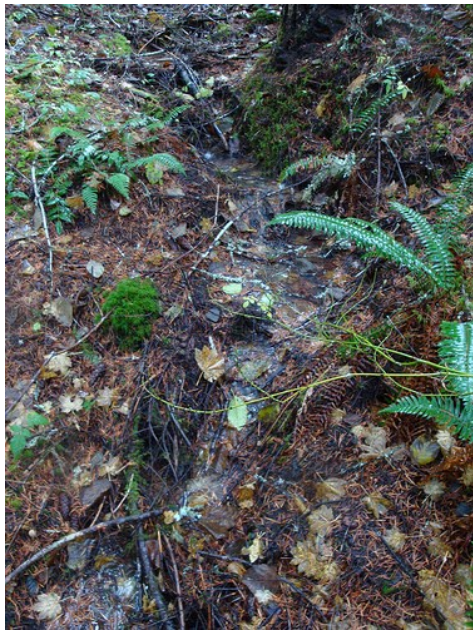
↙ This drainage is one of the many seeps and seasonal streams that we found throughout the units of the proposed sale that were not represented on the maps. Many more riparian areas exist than has been accounted for in these maps, likely because when the maps were surveyed for, the streams didn't exist. Earthflow, past logging, steep slopes and failing roads have changed the course of the waterways several times in the past decades. **How does the Forest Service plan to account for this in their analysis and Riparian Reserve guidance?**

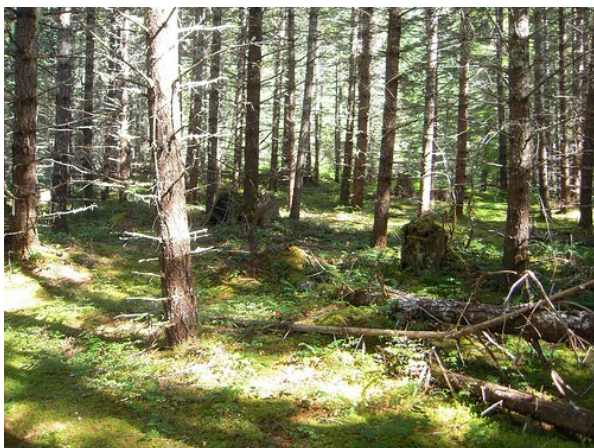
← Unit 36, south end of the unit. Although this forest is a plantation stand and has some of the least diversity of the units we looked at, this still has several decadent features and good spacing between the trees. **How much is there for a commercial timber operator to get from a stand like this?**

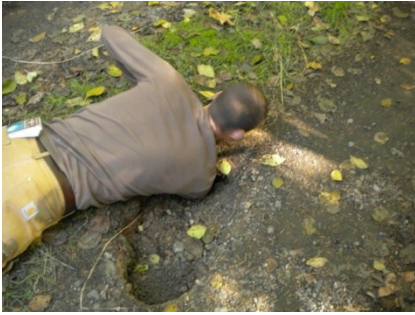
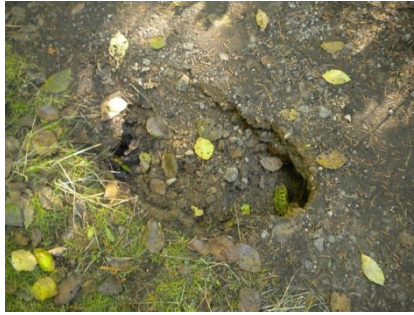
1 & 2. We witnessed a sinkhole, considerable sagging, and potential slides in the mainstem 6311.

Also up the road there was a large hole in the road itself. We found the crater itself after leaving Forest Service staff and so were unable to show him the location. But the hole itself is south of Cap Creek on Road 6311. There are signs of slumping here as well, and seemingly some of the water is penetrating the roadway and creating this cavity. We are concerned that this might be the road starting to wash away. Or that this cavity will only deepen, perhaps picking up momentum and blowing out the side of the road.

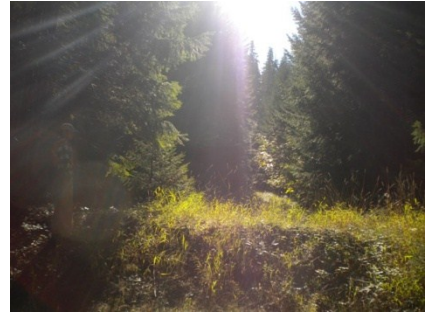
3

3. The decommissioning that has happened at the end of the road appears to be effective.

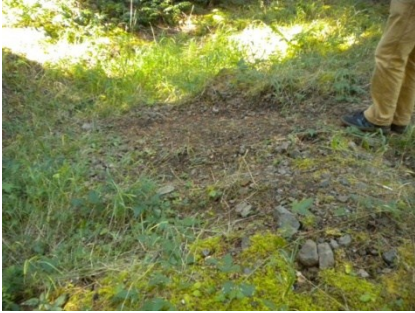
4

4. However, we did see some signs of ATV tracks going over the berms

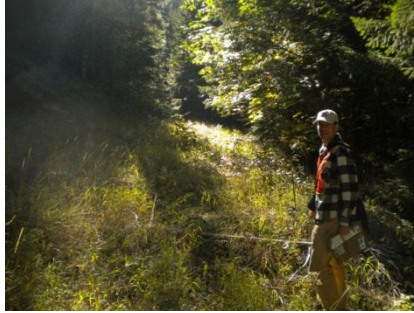
5

5. The road bed of 6311, beyond the decommissioned end of the road has successfully downsloped, beginning to become more aligned with the natural slope.

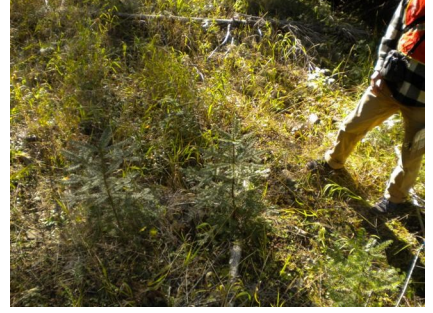
6

6. New growth has started to take hold in the decommissioned section of 6311.

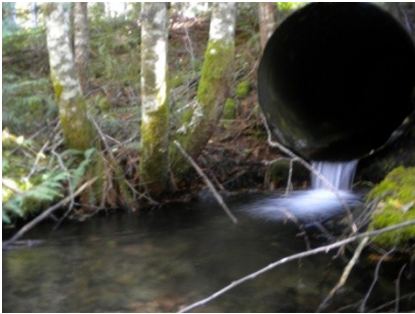
7

7. The culvert for Peat Creek is improperly placed and has created a pooling at the outflow. This pooling will degrade the fill of the road bed.

With regards to the sediment we saw along Cap Creek and also along Peat Creek, and the major damage to both of these crossings, coupled with the fact we are not able to fully comprehend the cause of the extensive slumping we have seen in many of these creeks, because of the numerous wet areas we have seen in many of these units, and the presence of anadromous fish we strongly encourage the agency to wait until spring when these areas are actively flowing to fully analyze the effects of this proposal through the Environmental Analysis.

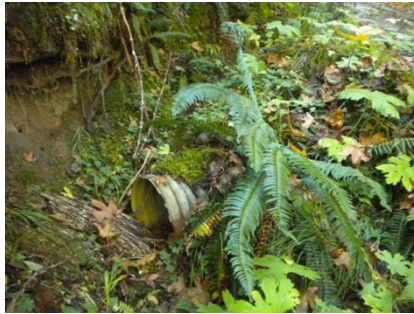
8

8. We have seen culverts that are likely going to plug. This is the culvert leading into the wetland.

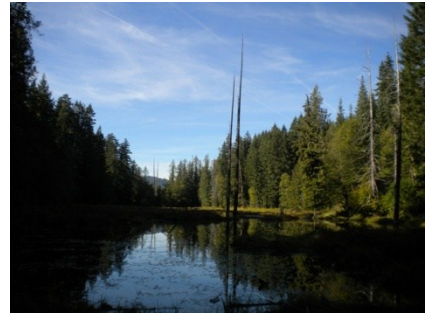
9

9. The hairpin on road 6311 that bend around the shore of this wetland is beginning to give out and is presenting unsafe travel and potential impacts to the wetland.

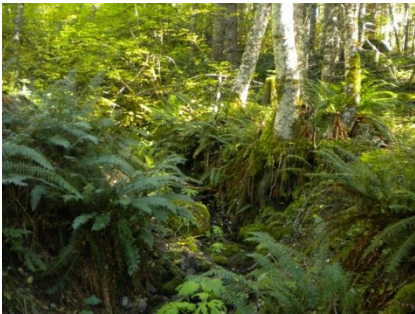
10

10. The proposed re-opening of old spurs into Unit 26 would force this stream to be put back into a culvert. We wholly oppose this action from happening.

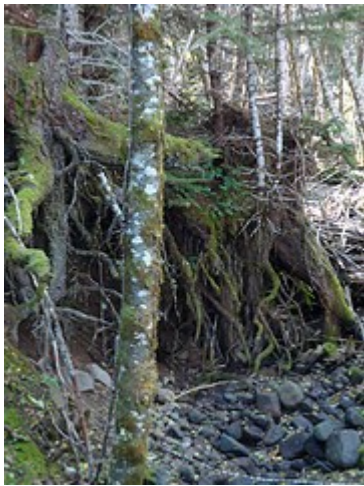
The presence of high earthflow has led to many unique geological and soil features throughout the forest. Several of the streams have many braided outlets throughout the forest that are taking advantage of shifting earth.

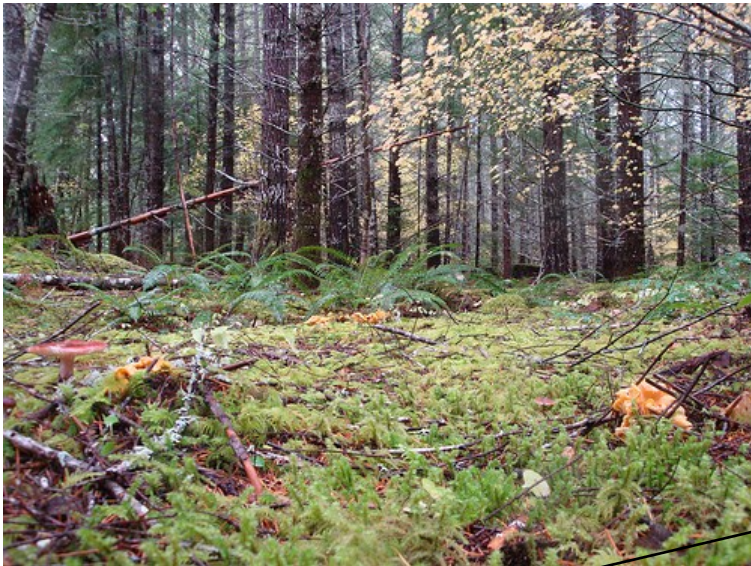
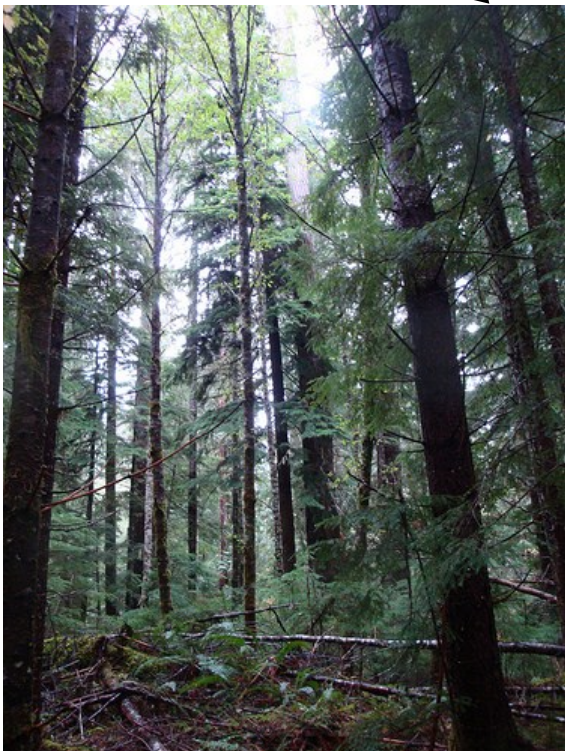
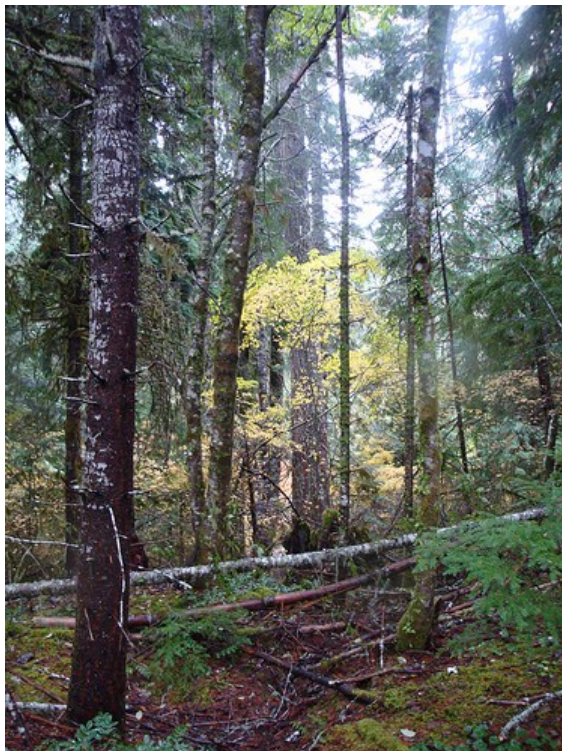
Like all of the LSR units that are being proposed, Unit 4 is adjacent to healthy old growth forests. These units have forests that are recovering from past logging and benefitting from the healthy and diverse forests around them. **We strongly urge the Forest Service to drop all units that are in LSR.** These photos show what we believe is the edge of the unit looking into the transition to older, mature forests.

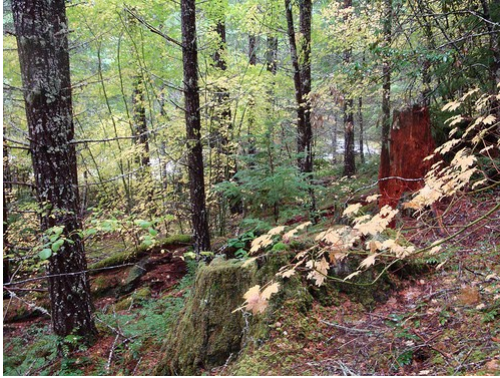
Unit 2 is surrounded on all sides by wetland and streams. **How does the Forest Service expect to avoid impacts into this important drainage into the Cap Creek?**

In Unit 2, we found a wet area with standing water along the west side of the unit that wasn't indicated on any of the maps. There were pools of water in many locations and skunk cabbage and alders all along the west side of the unit. The unit itself is a decent sized hill with about a 25% slope above the eastern and western streams in the unit. At the top of the hill, a 100 feet or so gain in elevation, there were a few chinquapin and rhododendron which according to *Natural Vegetation of Oregon and Washington* by Franklin and Dyrness indicates that this is the driest area in low elevation forests. This seems important to note because it shows that moisture is running off this hill rather quickly and into the drainage(s). Logging this area will only hasten this loss of moisture and add greater sediment and flow to these streams. These streams are also the headwaters for Cap Creek, and as we mentioned above the troubles with Cap Creek's crossing with 6311, we are concerned that this might be exacerbated by logging this unit.

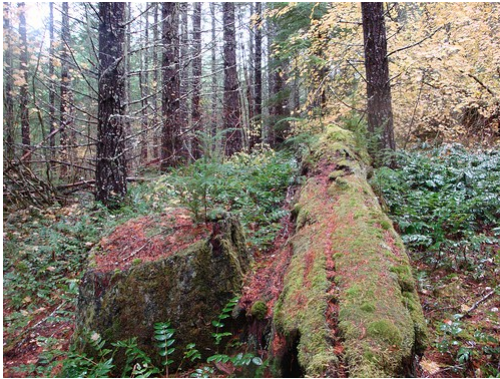
The level of downed woody debris, here in unit 2, is left from both past logging and natural decay. It has provided a good diversity of biomass structure in the plantation forests.

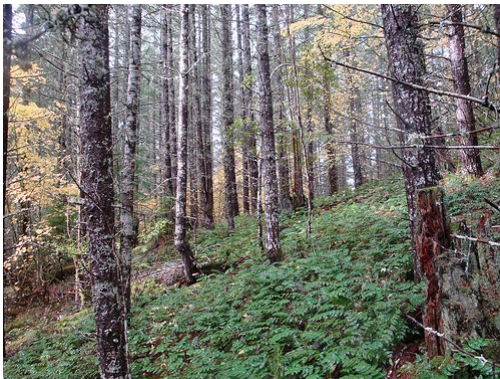
This image of Unit 2 shows one of the many indicators of high earthflow activity. The tree growing to the right in the picture is likely compensating for the movement of the slope that it is growing in, causing the bend in the trunk at the bottom.

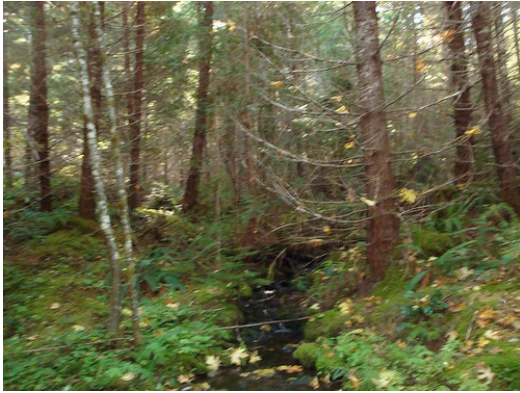
Stream in Unit 114. This unit is at the confluence of two drainages into the Collawash River. Like the other units with Riparian Reserve in them, this one has several streams not accounted for on the unit map provided to the public.

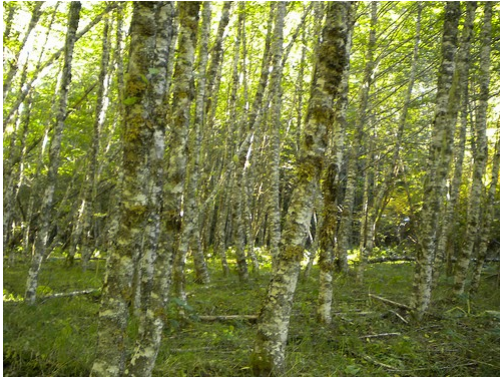
This wetland and red alder stand is adjacent to Unit 34 and is not accounted for on the map. These alder stands provide stability for shifting earthflow areas, but will not hold up to high levels of windthrow. Should logging occur, we have concerns about the loss of this stand from the increased exposure to wind.

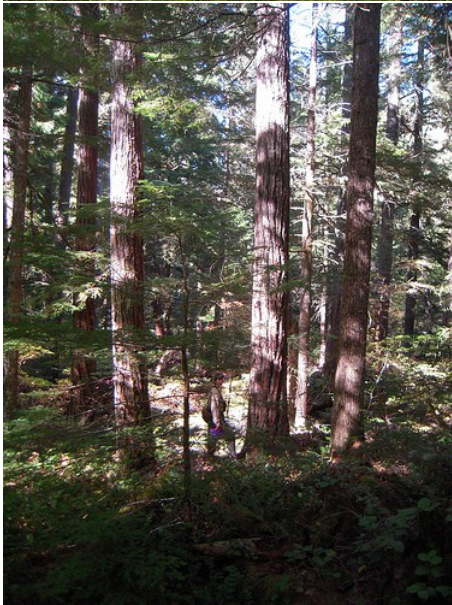
← This mature stand is adjacent to unit 40.

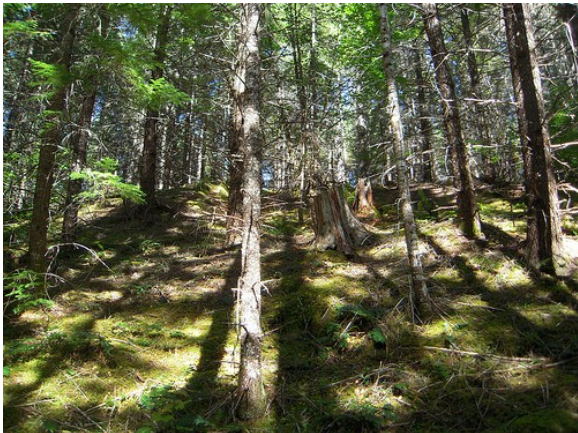
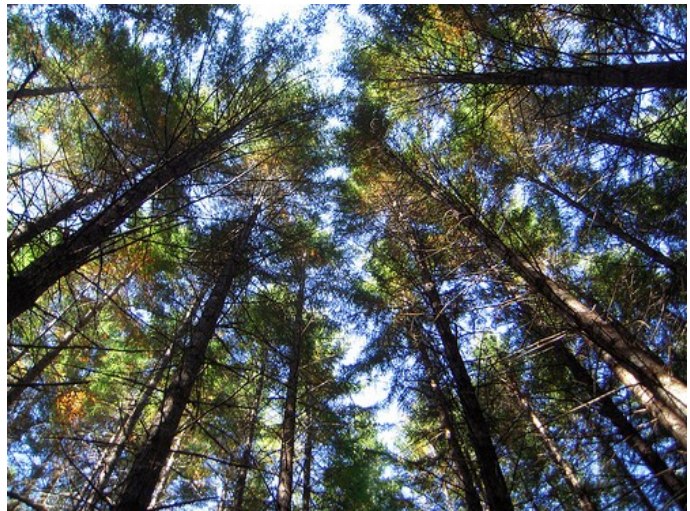
We do not see a need to thin these forests. The impacts that would be caused from roads being reopened, wildlife disturbance and aquatic degradation in a complicated system of riparian areas is not worth the potential speedy recruitment of larger trees and decadent features. The steep slope captured on the left is in Unit 36 and the canopy photograph is from Unit 38. Both of these photographs show a forest that is not in a great need of thinning.
